England's Heritage in Stone

Building stone as a resource

- finding stone for restoration projects

TIM YATES

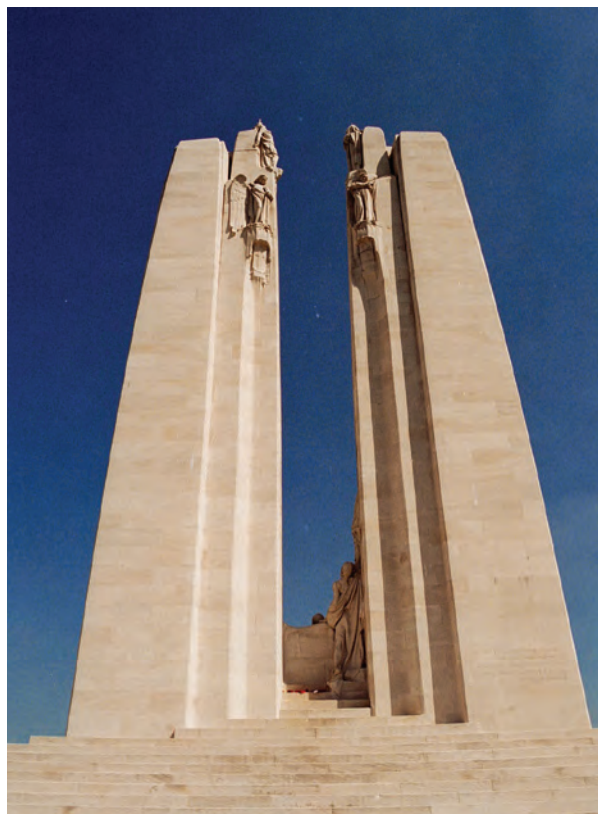
The twin 'pylons', each 67 metres in height, represent the countries of Canada and France (Fig. 1). Twenty sculptured figures on the monument and the names of 11,285 Canadians missing in France are carved on the walls. The monument took ten years to build and was unveiled on 29 July 1936.

Fig. 1. *The Vimy Ridge Memorial*

The original 'Trau' stone from the 'Dalmatian Coast' in what is now Croatia was selected with great care as it was intended that it should last for many years. However, the first problems were noted within 30 years and by the late 1990s there were plans for a major restoration to funded by Canadian Heritage to restore the plinth and the stone panels containing the names of those killed or missing from the Canadian forces. The preparation work for this project was undertaken between 2000 and 2002 as a joint project by Canada, UK and Serbia.

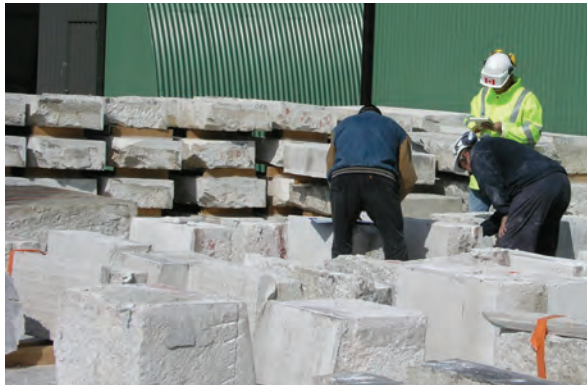
Fig. 2. Matching the stone at Vimy

Samples of the stone were collected and tested, and proved to be a very good match and to be sufficiently durable to be a good choice for the restoration (Fig. 2). Despite the success in sourcing the stone, difficulties were encountered in actually obtaining stone for the restoration

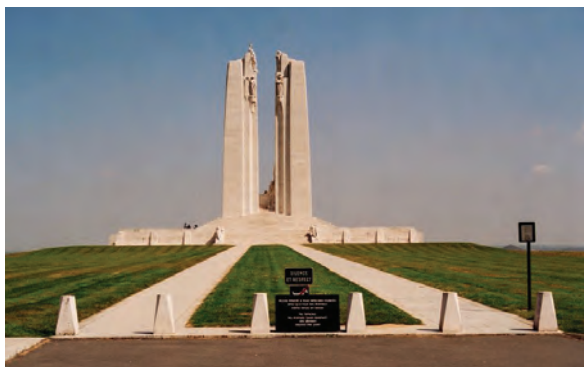
Fig. 3. The Vimy Ridge Memorial restored

project due to arguments over the ownership of the quarry and the availability of the stone, which resulted in long delays in the actual restoration work. However, it is now complete and the site was re-dedicated in April 2007 on the 90th anniversary of the assault on the Ridge (Fig. 3).

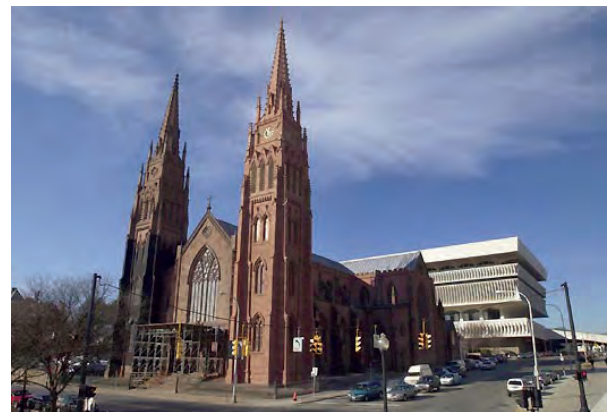
The Cathedral of the Immaculate Conception, Albany, New York State (USA) was initially constructed between 1848 and 1852 (Fig. 4). The design was by Patrick Charles Keeley and was inspired by Cologne Cathedral. The north spire was constructed in 1862 and the south spire in 1887. The cathedral was completed in 1892 with the construction of the sanctuary and sacristies at the west end. The cathedral is now part of a major urban area and the stonework has decayed – particularly the more exposed stonework in the spires and the clerestory – and by 2000 it was in need of replacement.

Fig. 4. Albany Cathedral, New York
