# England's Heritage in Stone

*Proceedings of a Conference*

# Historical Perspective of Conservation: the importance of stone, today's problems and lessons from the past

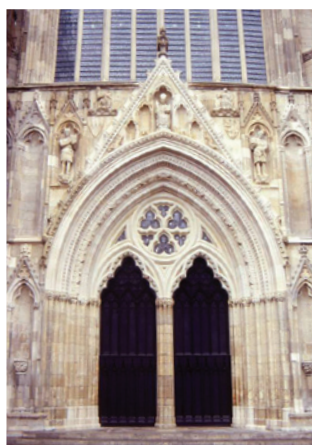
**Fig. 1.** Until the 1990s the general practice of the York Minster in-house masons was to replace decayed stone rather than repair it. The work to the Great West Door, however, was a very successful blend of the two. Where replacement was essential eg the arch voussoirs, decayed stone was replaced with new magnesium limestone to a contemporary design.

The conservation approach is to try and keep as much original fabric as possible. In 1978 seriously decayed arch stones were treated with Brethane, a specially devised consolidant to slow the natural decay. However, for various reasons this was not entirely successful, and there was continuous loss up to 1997 when its condition was re-evaluated.

The arch voussoirs were replaced by the Cathedral masons with new magnesium limestone to a contemporary design (Fig 1). Lime shelter coats (Fig 2) and mortar repairs were made to the rest of the superstructure to conserve

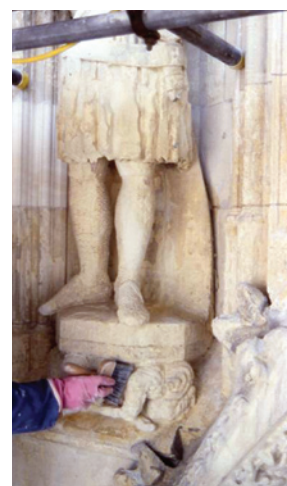
**Fig. 2.** On the superstructure of York Minster's Great West Door, lime shelter coats and mortar repairs were also used to conserve the stone and blend with the new work.

these and blend it with the new work. The completed job and the approach adopted has been favourably received.

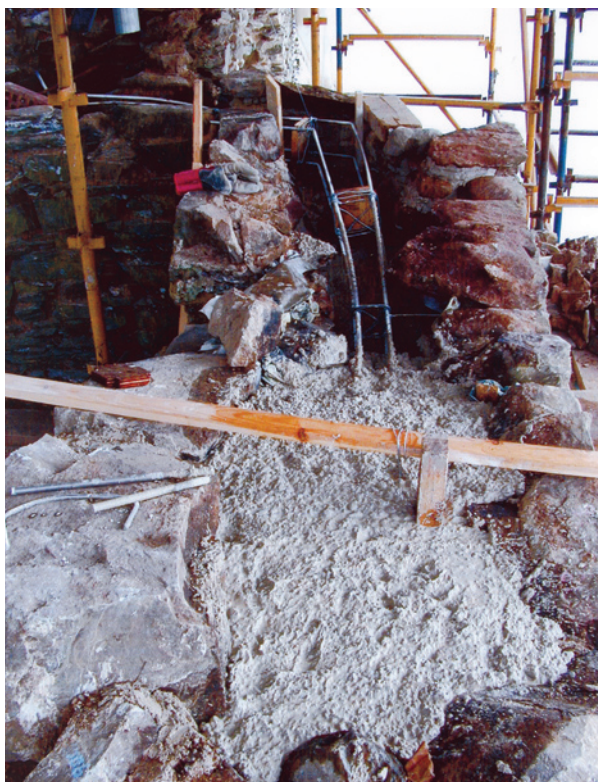
**Fig. 5.** Various works of consolidation were undertaken at Tintern which raised 'considerable anxiety' for some members of the SPAB Committee. These included trenched ring-beams built into wall-heads as in this recent example. The use of ironwork was strongly opposed by some SPAB members – predicting the iron would rust and cause huge disruption. Interestingly, discussions with those looking after the monument since the Second World War confirm that there has been no rusting or failure.

There was much criticism in the national press in 1922 and this extended to the way that other monuments in state ownership were being looked after. One issue was the presentation of ruins and the extent to which they should be stripped of long-established vegetation. A more specific issue at Tintern concerned the use of ferro-concrete in stabilisation. Trenched ringbeams were built into wall-heads (Fig 5). The use of ironwork was strongly opposed by some

SPAB committee members – predicting the iron would rust and cause huge disruption at the wall-head. Interestingly, discussions with those looking after the monument since the Second World War confirm that there has been no rusting or failure at wall-head. Back in the early part of the century, the alternative to the ferro-concrete would have meant more rebuilding of the structure and new buttressing.

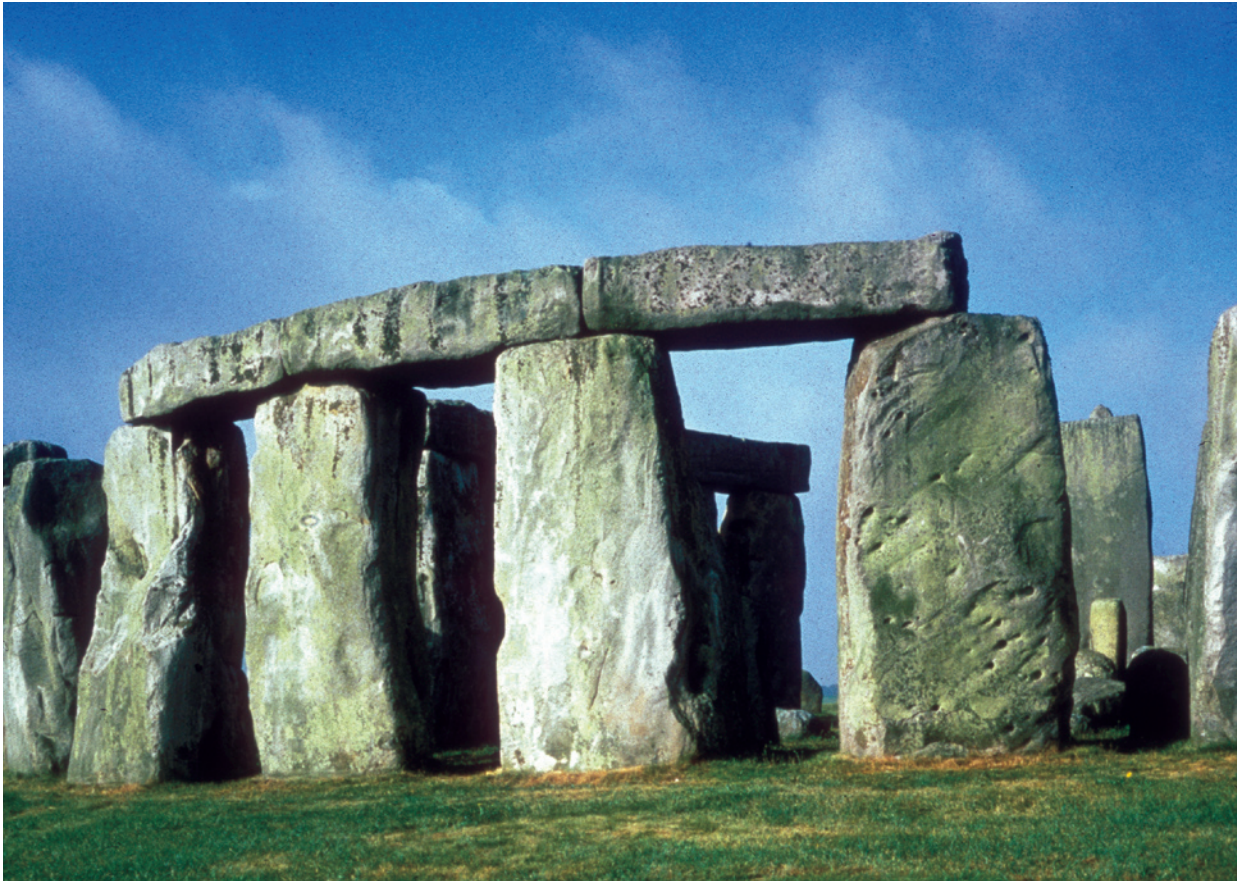
**Fig. 7.** *Our stone legacy spans four millennia and there is no better example than Stonehenge of the wider importance of a site than merely the structure which stands on it.*

Our stone legacy spans four millennia and there is no better example than Stonehenge of the wider importance of a site than merely the structure which stands upon it (Fig 7). It is in English Heritage guardianship being both a scheduled ancient monument and world heritage site and has a huge cultural and social significance. But this includes a wide area of surrounding landscape with many more ancient monuments and historic remnants. As a result we are looking at very grandiose plans for its enhancement which include undergrounding roads, and the construction of a new visitor centre well away from the stones.

In terms of the structure and its significance, we know that the stones were imported. The sarsens were brought from the Marlborough Downs and the bluestones from South Wales, which involved a massive human effort. A relatively high level of workmanship is evident from the tooling and the mortice and tenon arrangement for posts and lintels. Although the stones are aligned to the summer solstice and appear to have an astrological significance, we are not certain what its purpose was or how it was used.

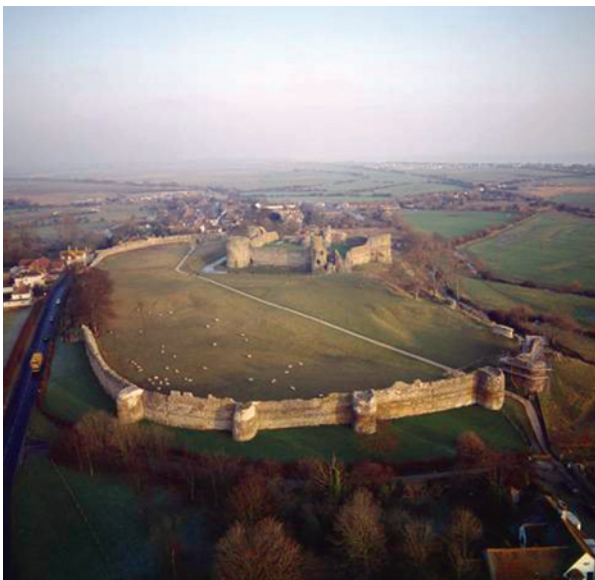
**Fig. 8.** *The construction of stone buildings needs great skill in workmanship and an understanding of materials. This is evident in Pevensey Castle a Saxon fort dating from 280AD.*

The Romans gave us composite construction; two facing walls with a rubble core which was a very resilient form of construction still used in the twentieth century. Again, great skills in workmanship and an understanding of materials is evident. Pevensey Castle (Fig 8), a Saxon

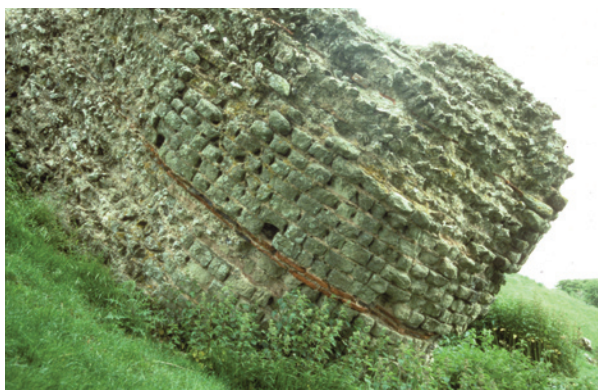
**Fig. 9.** At Pevensey Castle the remnants of a bastion which fell in the fifth century remains intact today.

Shore fort dating from around 280 AD has a fallen bastion, the remnants of which are in a remarkably good condition and survive today where they fell in the fifth century (Fig 9). The fort was originally built on the coast but sea levels rose, which undermined the footings. Archaeolo-

gists have shown that some of the timber foundations are missing. One suggestion was that as Roman construction gangs were in direct competition with each other and speed determined pay, a rival gang could have sabotaged their work. The other point to emphasise is the quality of Roman mortar, which has survived even though neglected for over 1500 years. Within the original curtain wall it has eroded back to the same line as the soft Greensand stone it surrounds, something that modern cement would not do. Unfortunately, twentieth century wall cappings have been carried out in cements, which have caused considerable difficulties in successfully maintaining these monuments. They invariably crack or worse, cause the surrounding masonry to crack, which lets in water and again is subject to the destructive forces of freezing and thawing.

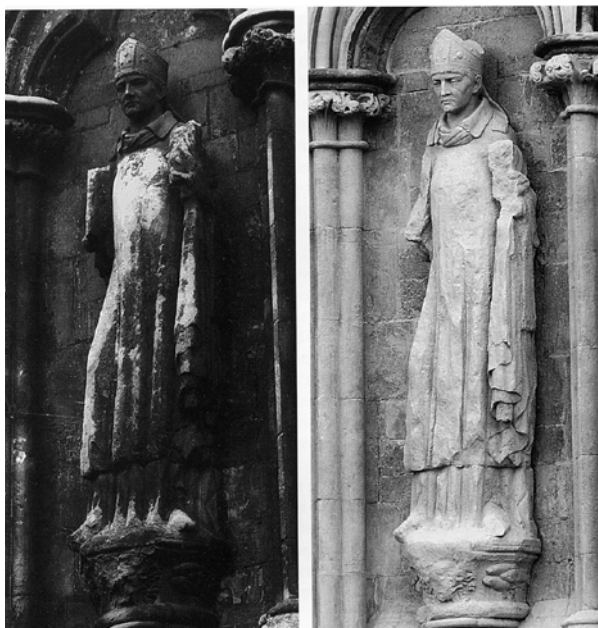
**Fig. 11.** Research has been funded into conservation techniques such as low-pressure cleaning and lime mortar repair.

Most of our funding has been for grants for repair works, the most recent being the conservation of statuary on the West Front. This included various methods of low-pressure cleaning and lime mortar repairs (Fig 11).

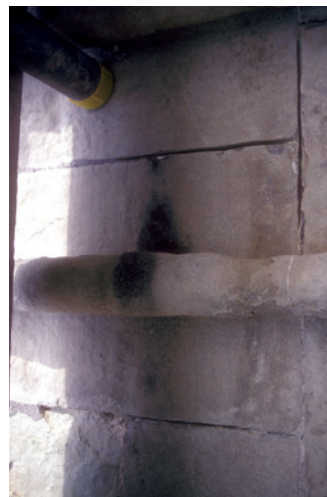
**Fig. 12.** Too often building repair techniques have been damaging in themselves. Cutting out mortar joints with angle grinders will often damage the stone even when carefully executed. English Heritage has developed training programmes to improve skills.

grinders had previously been used to cut out old mortar joints. These can cause a lot of damage, but even though it was carried out carefully, damage to stones was still evident (Fig 12). In the training exercise, hand tools proved to be perfectly effective. It is our view that in many instances

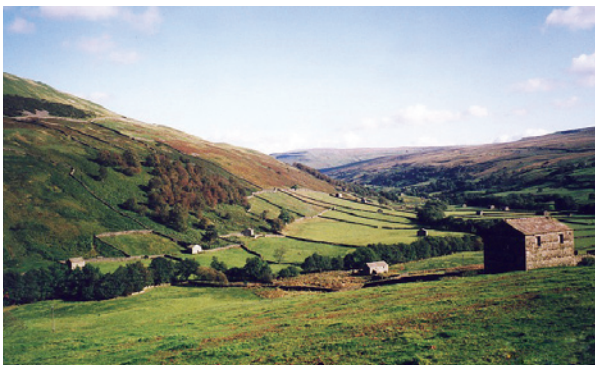
**Fig. 14.** *The Swaledale dry stone walls and field barns are one example of successful conservation. This was in large part due to the existence of one very small quarry which could supply the original stone for repairs to walls and roofs. Unfortunately in many regions authentic stone is simply not available.*

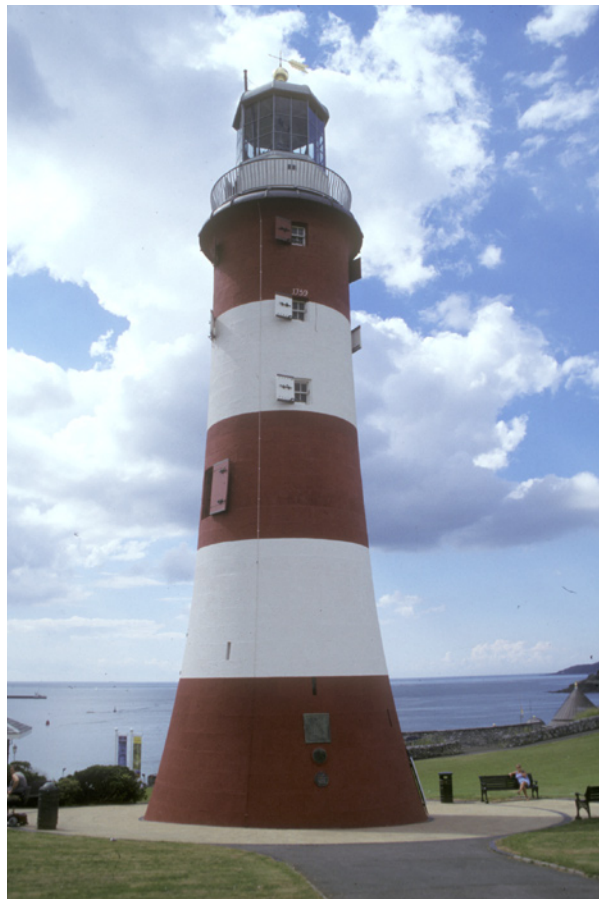
**Fig. 16.** *Some structures such as the third Eddystone lighthouse, show the unique quality of stone as the only material that could perform in the most hostile conditions. Two of the reasons for its success were the quality of the Devonian moorstone granite blocks and the well researched mortar using eminently hydraulic lime from Watchet in Somerset with a pozzolana giving a very quick set but accommodating the requisite movement.*

All these examples have shown how important stone is in providing local distinctiveness. There are some structures, which show the unique quality of stone as the only material that could perform in the most hostile conditions. An excellent example is the third Eddystone lighthouse which was built on a reef 14 miles south of Plymouth and which was dismantled and moved to Plymouth Hoe in the 1880s. It is now a Grade I listed building (Fig 16).

The first two lighthouses were destroyed so in the 1757 John Smeaton was commissioned to design a replacement. It was a superb feat of design and engineering being the first wave-washed rock light to successfully develop and prove the principles and strength of interlocking masonry. Each stone was carefully dressed to interlock with its neighbour and these were locked into place with the use of marble joggles (Fig 17). There were three other reasons for the success of the new Eddystone. Firstly, the quality of the Devonian

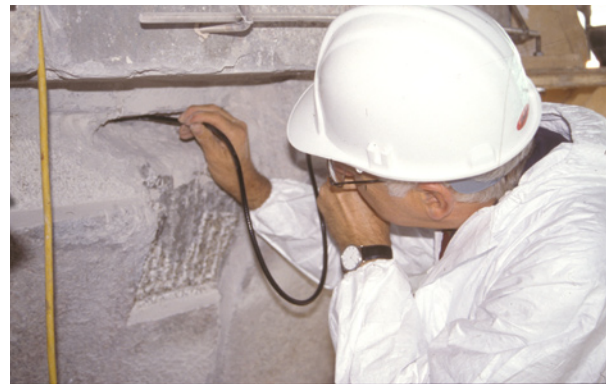
**Fig. 18.** Unfortunately when the Victorians moved the Eddystone lighthouse to Plymouth Hoe they were not too concerned with replicating details, using a copious amount of cement, ignoring the marble joggles and the chains that held the structure together. As a result there were a number of problems including water penetration.

The lighthouse on Plymouth Hoe is now a tourist attraction and we were involved with grant aid and advising on its repair (Fig 18). Ironically the main problem was damp penetration. The Victorians on moving it were not too concerned with replicating details, using a copious amount of cement, ignoring the marble joggles and the chains that held the structure together. As a result there were a number of problems. The tragedy is that dressed granite, of

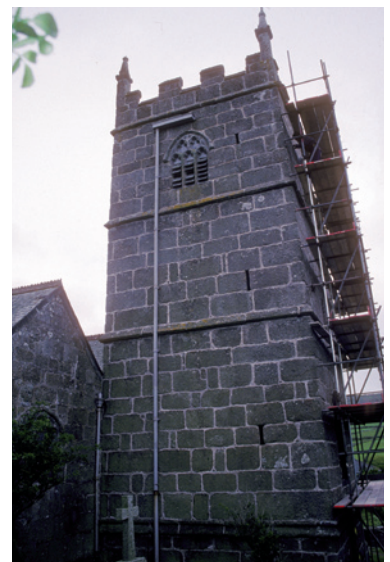
**Fig. 19.** The problems of driving rain penetrating solid masonry walls and the potential solutions are something that English Heritage are currently studying. The tower of Zennor Church in Cornwall is typical. Built of ashlar granite the bed joints touch a few millimetres in so there is very little mortar to resist water ingress. To overcome this walls were originally either rendered or had lime slurries and limewash regularly applied even though this would obscure the decorative appearance of the ashlar blocks

The problems of driving rain on solid masonry walls and the potential solutions are something that we are currently studying. The granite tower of Zennor Church in Cornwall is typical (Fig 19). Again it is built of ashlar granite, but unlike the old Eddystone still suffers from damp. Unlike Smeaton's interlocking stone, this is not cut six sides square, with the result that bed joints touch a few millimetres

in, so there is very little mortar to resist water ingress. Our forefathers knew this and most of these towers, even ashlar ones were either rendered or had lime slurries and limewash regularly applied. So much of this was lost with

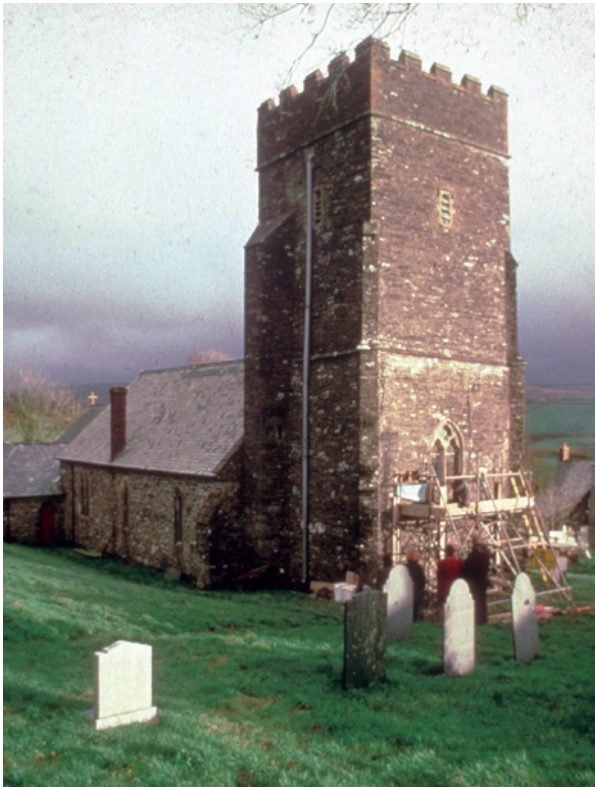
**Fig. 20.** The scraping clean associated with the nineteenth century restorations removed much of the limewash or render leading to water penetration. Challacombe Church in North Devon was originally rendered but this was stripped in the nineteenth century

the scraping clean associated with the nineteenth century restorations. Challacombe Church in North Devon was originally rendered but this was stripped in the nineteenth century (Fig 20). Driving rain caused significant penetrating damp with ferns growing on the inside face of the tower. Levels of damp have been monitored for the last few years and the subsequent repairs and rendering have resulted in a dramatic drying of the structure (Fig 21).

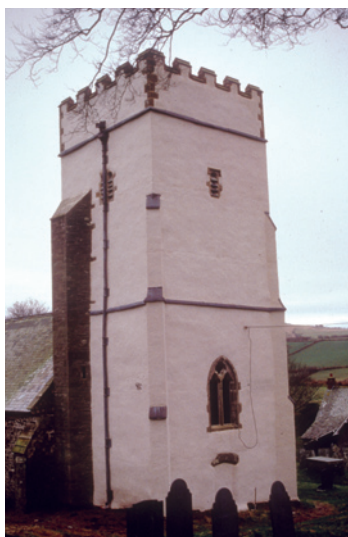
**Fig. 22.** The problems with traditional hard cap wall protection are being researched. Lime mortars are sometimes not durable enough to resist harsh climates and cements trap moisture and are prone to cracking. Grass caps are being tested at a number of sites including Byland abbey.

North Yorkshire, an English Heritage property (Fig 22). The problems with 'traditional' hard caps have been that lime mortars are sometimes not durable enough to resist harsh climates and cements trap moisture and are prone to cracking. The experiments with turfs aim to assess their effectiveness at preventing water ingress and minimising temperature extremes at the wall head. Results so far are looking very promising.

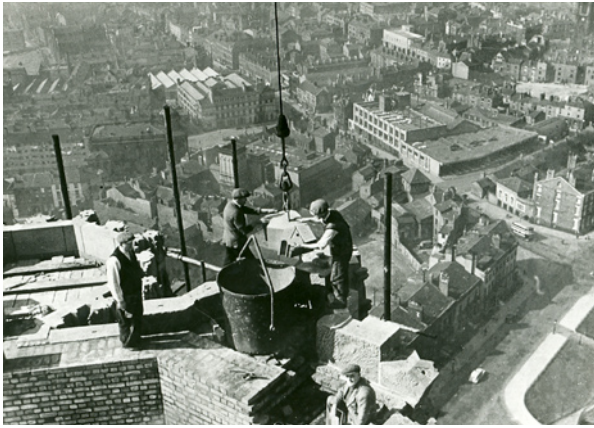
**Fig. 23.** In more recent buildings such as Liverpool's Anglican Cathedral we have good records of its construction and detailing. Despite of a high level of construction and masonry skills, recent repairs have highlighted a problem with the materials and techniques originally used. A lot of pointing had dropped out and some of the edges of stones were spalling because cement mortar had been used over a lime ash core mortar.

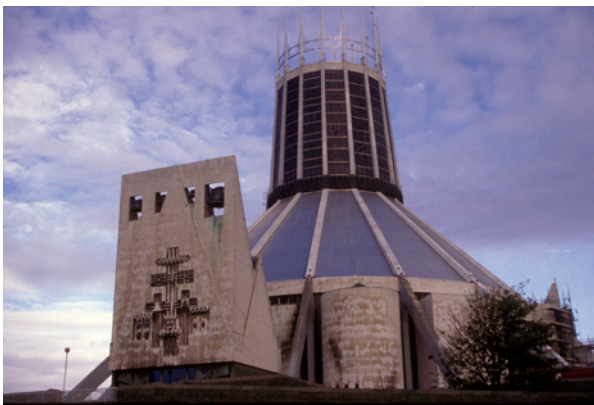
**Fig. 25.** A number of listed modern stone built or stone clad buildings have undergone extensive works of repair. At Liverpool's Roman Catholic Cathedral the work has concentrated on the Portland stone chapels. In time all these modern buildings will need stone to repair them.

extensive works of repair. At Liverpool's Roman Catholic Cathedral (Fig 25) work has concentrated on the Portland stone chapels. In time all these buildings will need stone to repair them.

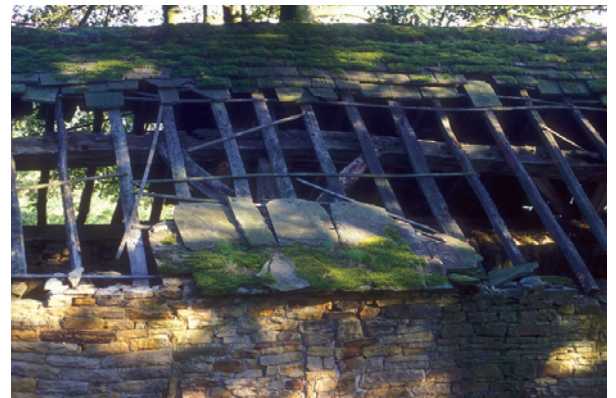
**Fig. 26.** Two consequences of a lack of supplies of new stone are that roofs are cannibalised or in extreme cases stolen.

stolen (Fig 26). The other result is that we see concrete substitutes or more foreign imports whose longevity and performance is unknown and which are likely to weather very differently.

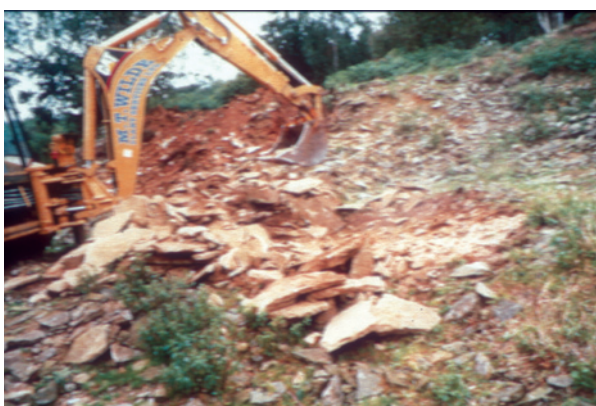
**Fig. 28.** In order to be able re-slate the Harnage roof of Pitchford Church in Shropshire, a number of potential stone slate sources were investigated so as to establish the size of the resource and the suitability of the stone.

We had to investigate a number of potential sites where good quality fissile stone could be found (Fig 28). This is an essential part of the process and as well as establishing the size of the resource, detailed petrographical assessment was needed to establish the quality of the stone. A bolster and lump hammer is needed on site to establish the fissility of the material and ensure that it can be dressed satisfactorily. Part of the grant for the works included finding a suit-

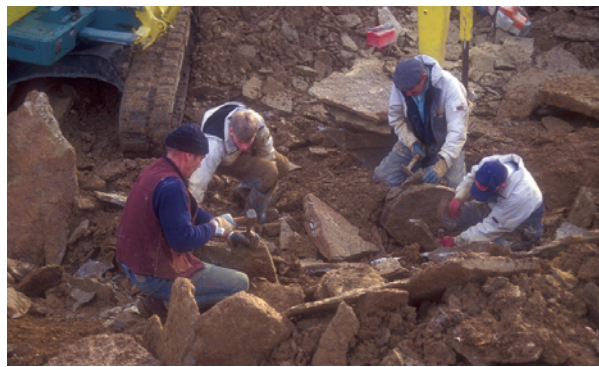
**Fig. 29.** Part of the grant for the Pitchford church roofing works included finding a suitable source of new material, and to win enough to cover the whole roof; with any surplus stored for use on other Harnage roofs. Quarrying for stone slates is still essentially a hand operation.

able source of new material, and to win enough to cover the whole roof; with any surplus stored for use on other Harnage roofs. Quarrying for stone slates is still essentially a hand operation (Fig 29). The cost of this was included as part of the grant and it was a nerve-racking time, as only so much funding was available and it was vital to make sure

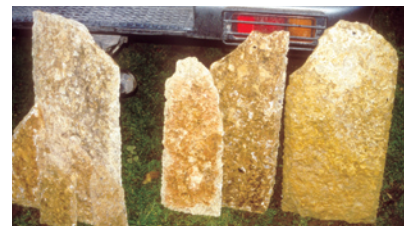
**Fig. 30.**

Production at the quarry resulted in these roughly dressed slates prior to sending them away for further dressing. Detailed petrographical assessment was also needed to confirm the quality of the Harnage stone.

that enough good quality material was produced in the time allowed (Fig 30). To make it worse, the quarrying took place on the wettest month Shropshire had experienced since records began in 1841. The contractors completed the trimming and dressing under cover in their own premises

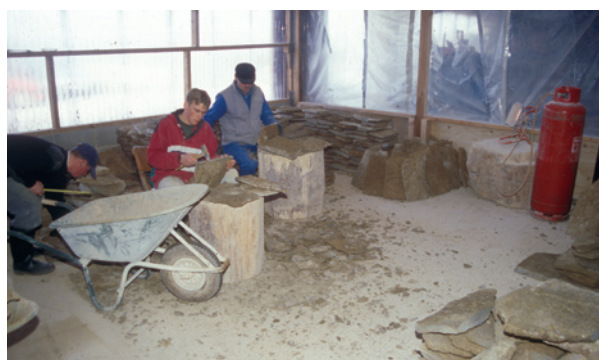
**Fig. 31.** The trimming and dressing was done under cover. This was more productive as well as more comfortable for the men. Equally importantly, it was a major factor in getting planning permission, because it meant minimum disturbance and traffic at the quarry site.

(Fig 31). This was obviously more productive as well as more comfortable for the men. Equally importantly, it was a major factor in getting planning permission, because it meant minimal disturbance and traffic at the quarry site.

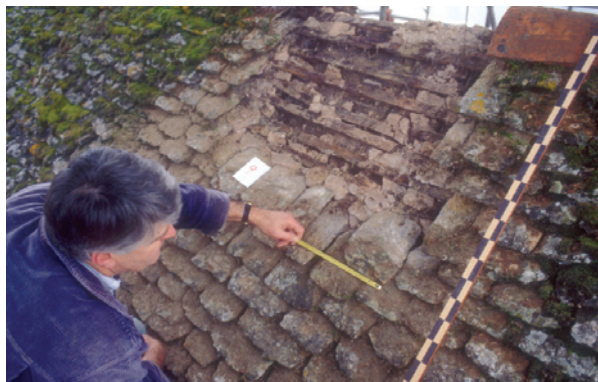
**Fig. 32.** A detailed investigation of the collapsing Pitchford Church roof was carried out to see why it had failed after only 60 years. A one-metre wide trench was excavated from ridge to eaves on both sides.

A detailed investigation of the roof was carried out to see why it had failed after only 60 years (Fig 32). A one-metre trench was excavated from ridge to eaves on both sides. The problem was that many of the slates were too small probably because they had had to use dressed down slates

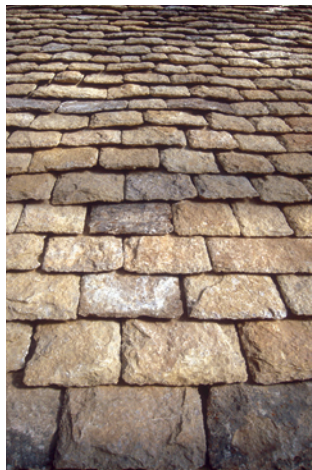
**Fig. 33.** In the end the replacement of the failed Pitchford Church roof used mainly new slates because the existing slates were too small to be reused especially after dressing off softened areas.

from the failed roof and had not found an adequate source for the production of new ones. (Contemporary correspondence had indicated that considerable effort had been made to find a new supply in the 1930s.) To compensate for the small sizes and inadequate head and side laps copious amounts of cement mortar had been used to bed the slates. This of course only encouraged and held further moisture and led to the laths and pegs rotting prematurely. In the end the replacement of the failed roof used mainly new slates (Fig 33).

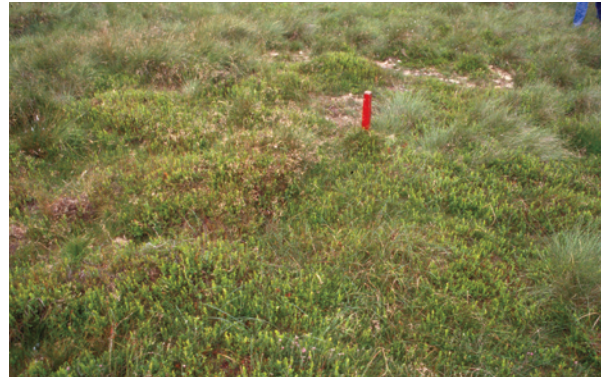
**Fig. 39.** Obtaining planning permission for small stone quarries is not always straightforward as at Pitchford and Abbey Dore. At Linshaws on the edge of the Peak District National Park, a very small scale proposal was eventually rejected because it was within a candidate Special Area of Conservation. The proposed quarry would have occupied one hectare in a 65,000 ha SAC and would not have threatened any of the priority species of flora. Indeed the existing flora recovered very quickly after the trial pit was back-filled.

Linshaws Quarry, near Holmfirth, West Yorkshire is an infamous case which highlights some fairly intractable difficulties. A local resident applied to re-open an old quarry to work the Rough Rock Flags right on the boundary line of the Peak District National Park in West Yorkshire. The site measured one hectare and was covered by a number of important designations, the most significant being a candidate Special Area of Conservation which covered 65,000 ha. No priority species of flora were threatened by the proposal and consultant ecologists concluded that the important heathland species would re-colonise quickly and other areas could be planted by way of compensation. Trial holes, which had been dug some months earlier, recolonised with some of the species within months (Fig 39). Nonetheless the application was eventually rejected.

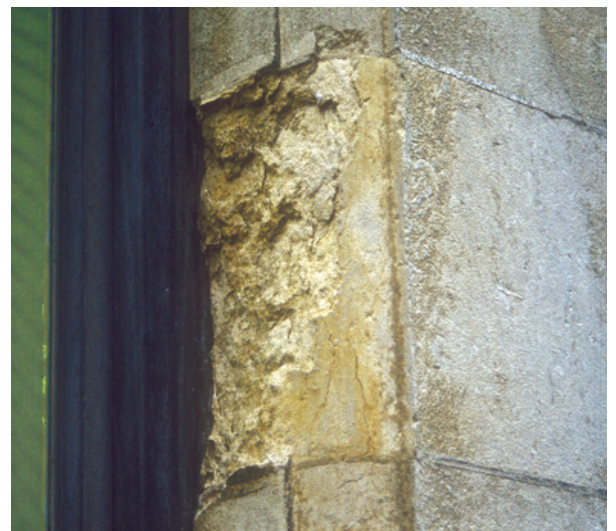
**Fig. 41.** Using the correct stone is of paramount importance if buildings are to be conserved correctly. The combination of Bath stone and granite at Truro Cathedral highlights a typical problem. The impermeability of the granite caused moisture to migrate to the more porous Bath stone resulting in its deterioration. In this case the Box Ground limestone appeared to be inferior. A range of English stones were tested in an environmental chamber at Sheffield Hallam University.

and Bath stone; an unfortunate combination because the impermeability of the granite caused moisture to migrate to the more porous Bath stone (Fig 41). In this case the Box Ground appeared to be inferior and not what Pearson had specified. Rather than agree to the current Architect's desire to use a French stone to repair, we tested a range of English stones in an environmental chamber at Sheffield Hallam University (Fig 42). This simulated the temperature and humidity ranges found at Truro and an accelerator put them through harsher tests (Fig 43). Standard durability tests were also carried out. The best performer was another Jurassic limestone, Syreford which I believe is being used for the repairs.

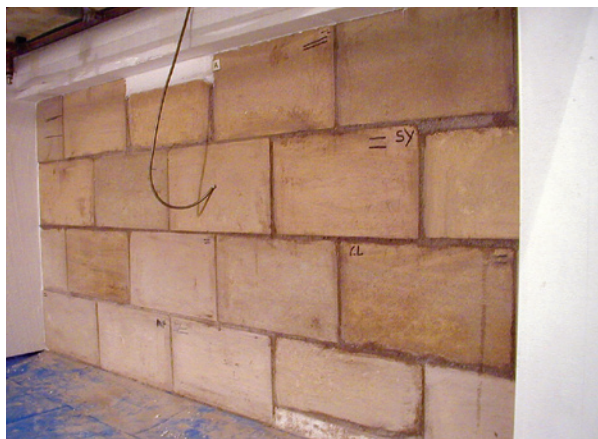
**Fig. 42.** *In the Sheffield Hallam environmental chamber accelerated temperature and humidity cycles found at Truro were simulated followed by standard stone durability tests.*

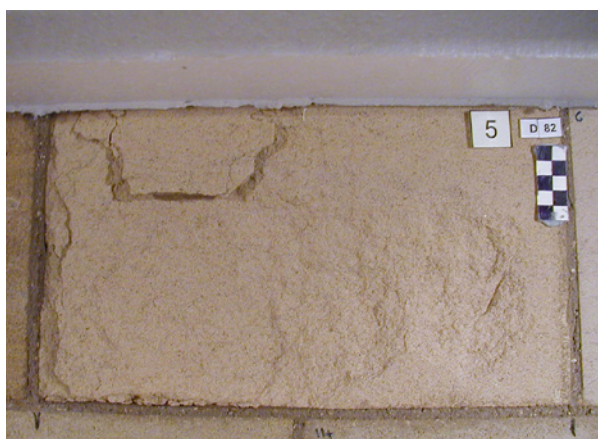
**Fig. 43.** *The environmental testing demonstrated that the best performer was another Jurassic limestone, Syreford.*
